## FAILURE ANALYSIS AND RECTIFICATION OF FISH MOUTH LIKE RUPTURE IN SUPERHEATER TUBE

**Abstract-** The present study is related to the superheater tube failure of Boiler-1 which is under operation at Karnaphuli Fertilizer Company Limited (KAFCO). Superheater is a crucial component of any boiler, and its failure leads to the shutdown of the entire plant. We investigated a fish mouth shaped rupture on the SA213-T11 secondary superheater coil that failed after running 78,840 hours. The reason for the fish mouth like rupture is short term overheating may be due to a restriction of steam flow for blockage inside tube although later no tube blockage observed by boroscopy inspection. Boroscopy was carried out in both headers if the tube is totally/partially plugged to prevent a second failure, and a videoscopic inspection was performed to find scale formation inside the tube. In the rectification process, the mellographic test was done to understand failed tube condition and identify the appropriate repair solution for short-term operation. Although the hardness tests of failed tube near the positions of welding ensured the suitability of replacement at reduced operating pressure, the ex

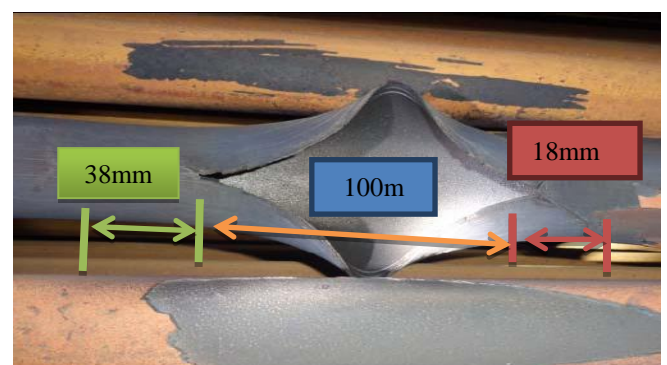
After shutting down the boiler, it took around 14 hours to cool down the boiler for internal inspection. Preliminary visual inspection revealed that, first tube of Secondary Superheater inlet (SH2 I<sup>0</sup>) (Tube No. 62) was ruptured and fish mouth appearance at ruptured spot was observed. Due to sudden rupture of tube no. 62, the outer leg of the tube heats the inner leg. Due to high pressure and temperature steam hydrojetting, adjacent tube No 61, 63, 64, 65 was found magenitite formation at tube outer surface and blackish scale was formed at the steam contact points. Fish mouth opening was estimated roughly 100 mm and at the edges of the mouth cracks are observed. The rupture tube was found bulged and bended due to the reaction force of leakage. The leaked tube bowed at inner direction around 16 inches.

Fig.3: Measurement of fracture surface

Reason for the fish mouth like rupture is short term overheating. A blockage inside tube might hinder the steam flow; however, no tube blockage could be detected while performing boroscopy inspection. Therefore, the reason of the failure could be attributed to the condition of increasing of fire-side convective coefficient and temperature, or decreasing of steam-side convective coefficient that leads to the curbed mass flow of steam, thereby causing a significant increase of the tube metal temperature. Such an increase in the temperature of the tube under high operating steam pressure results in creep rupture of the coil.

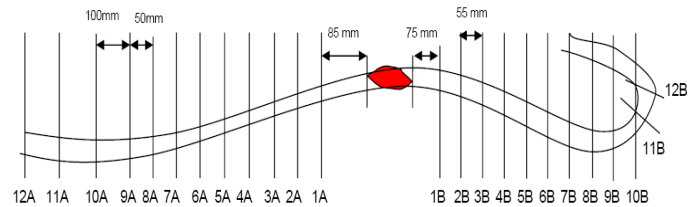
Fig.4: Thickness, hardness and diameter measurement data of damage tube

As per MACCHI's short time repair procedure, it was decided to replace the ruptured portion with the section of spare tube available with us. As shown in the above figure, it has been observed that significant change of diameter and thickness value occurred in the right side of the rupture, minor change of hardness value observed along the tube length. Sound tube portion can be utilized for welding by removing at least 300 mm from both edge of the cracked portion. However, we cut off the length of 1380 mm and connected a sort piece from a spare tube coil.

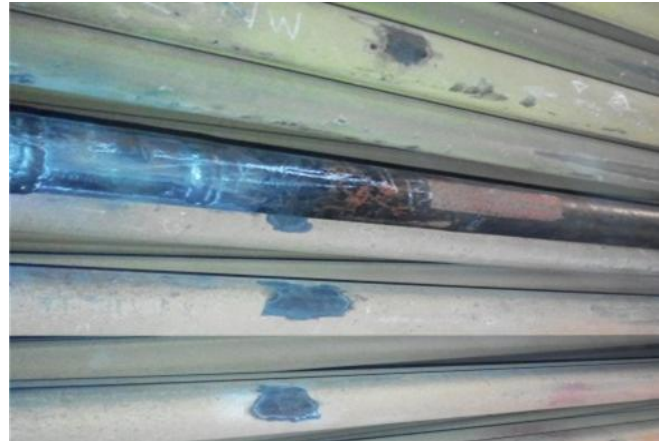
Radiographic test result revealed no linear indication on the weld, several rounded indication & root concavity has been observed. Excess penetration on the root of inner side welding and non-uniform welding profile of both side welding joint were observed. Overall welding condition was not satisfactory. However, all the indications were left for consideration due to extreme access limitation.

Fig.4: View after short piece welding.

1. Cut off damaged portion by length as long as the condition was found good. It was 1380 mm.
2. Straighten the tube end by heating (using gas burner) at bend position
3. Both end preparation

1. Cut a short piece of desired length from spare coil (Material SA 335 –T22).
2. Window cutting for inside welding form new short piece.
3. Outside and inside beveling to match with existing tube end.
4. Insert new short piece with maintaining root gap 2 to 3.2mm.
5. Root pass welding with GTAW process using Filler TGS-1CM (AWS 5.28 ER90S-G), Ø 2.4 mm.
6. DPT (dye penetrant test).
7. Final welding using GWAT process.
8. Installing the window by tack welding, that was cut to facilitate.
9. Root pass welding all around the window using Filler TGS-1CM, Ø 2.4 mm.
10. DPT.
11. Final pass welding all around the window using same filler.
12. RT(Radiographic test)

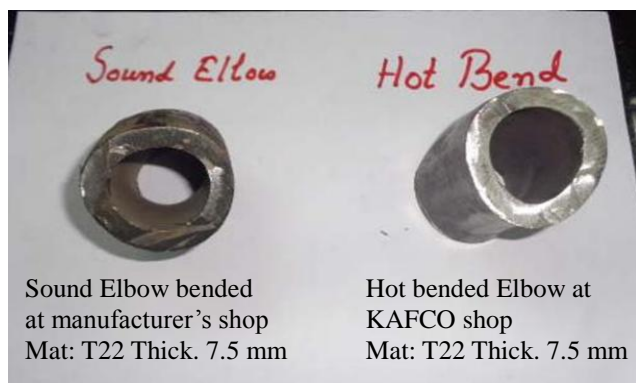
Fig.5: Sound elbow and hot bend.

Hot bending was performed by heating up one of the 90° Elbow by using oxy-acetylene flame. The heating continued up to 670~710°C uniformly. One arm of the pipe was fixed firmly and heating was applied on the elbow. When the material reached temperature around 700°C, free arm of the tube was pressed slowly until the 90° elbow turns 35°. After completion of bending, tension on the tube released and allows the material to cool down in ambient air. Hardness was measured before and after bending action by the help of rebound ball hardness meter. Visual inspection after bending also confirms there is no surface crack on the tube surface. Hardness before hot bending were 105~121 HB, whereas hardness after hot bending were 110~129 HB.

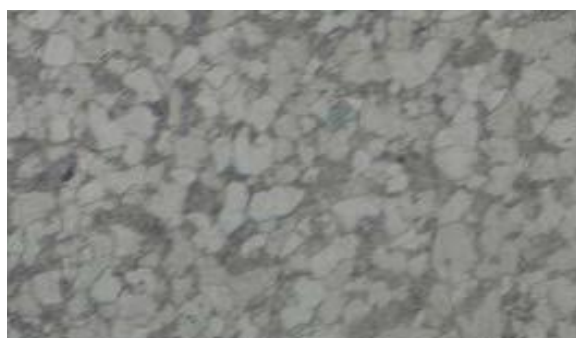
Fig.6: Sound elbow from Manufacturers shop (100X)

Both hot & sound elbow shows normal ferrite-pearlite type structure. Grain size for both the condition remains same. Any kind of significant difference between these two microstructures has not been observed.
