CONSIDERATION OF SOIL PROPERTIES FOR STABILITY ANALYSES OF PADMA AND JAMUNA RIVERBANK

This study deals with the characterization of Padma and Jamuna river bank soil and evaluation of river bank stability corresponding to those soil characteristics. It has been found that in some cases Padma and Jamuna river bank show distinct soil characteristics. A typical river bank section has been taken considering the geometric pattern of the rivers of Bangladesh. Stability analyses were conducted for three slopes, 33°, 45° and 56°, for different conditions using Geo-Studio 2012. For Padma and Jamuna river bank soils, specific gravity and liquid limits are quite similar whereas plastic limits are slightly higher for Jamuna soil. Again permeability of these soils is quite low leading to greater hydrostatic pressure. Cohesion and friction angle of Padma and Jamuna river bank soils are also comparable but their variation with change in water content and depth needs further study. In addition, from embankment section analysis, it is found that the factor of safety (FS) is overestimated about 25 to 30% if seepage is not considered in designing embankment. For river banks, it has been estimated tha

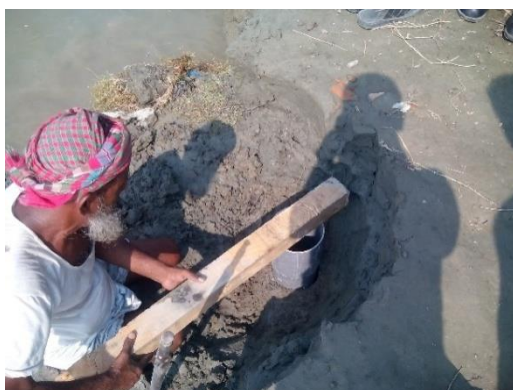
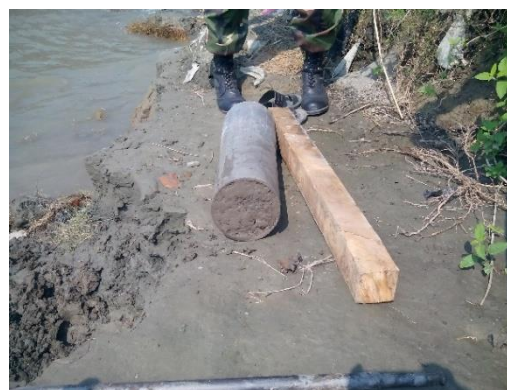
Fig. 2: (a) Pushing the PVC pipe into soil using a wooden plank, (b) soil sample collection by PVC pipe
RESULTS AND DISCUSSIONS

The soil samples were collected from the broken part of the Padma riverbank near Mawa ferrighat and also from the Jamuna riverbank near Sariakandi Upazila as shown in Figure 1. Soil was collected from approximately 0.5 m depth using Shelby tube as well as PVC pipe from each location shown in Figure 2. Thus, the collected soil samples were slightly disturbed. The testing procedures were in accordance with ASTM Standards and the soils have been classified according to USCS. The constant head method was followed to determine the coefficient of permeability. Unconfined compression test was carried out on samples having different water content.

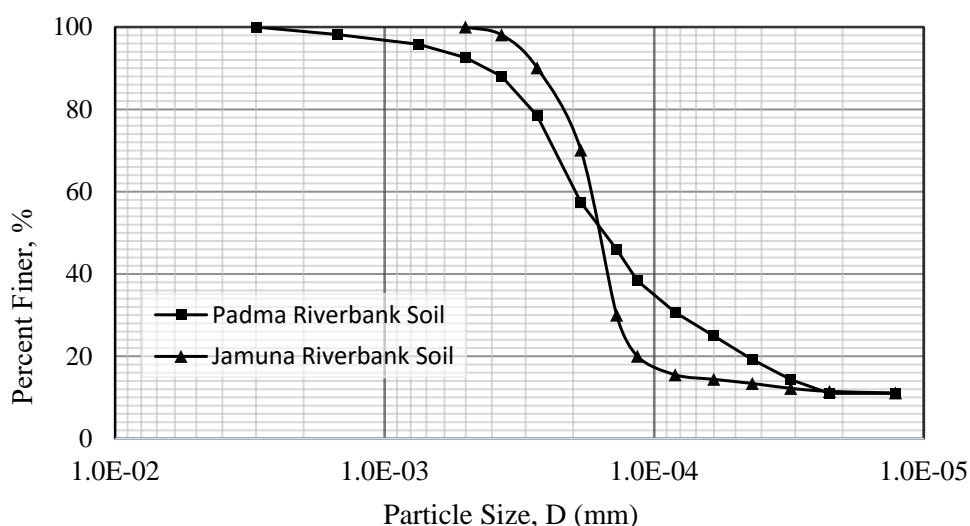
Fig. 1: Particle size distribution of the riverbank soils

From laboratory analyses, it has been found that liquid limit and specific gravity of those soils are quite similar but plastic limit is reasonably higher for Jamuna riverbank soil. Maximum dry density for Padma riverbank is found to be 1.54 gm/cc which is greater than the corresponding 1.28 gm/cc for Jamuna riverbank. From particle size distribution curve, it can be inferred that silts and clay governs the majority and this relation is shown in Fig. 3. Both the soils are low plastic clay (CL). Optimum water content has been determined for both soils which can be significantly useful in riverbank construction. Relationship between dry bulk density and water content has been shown in Fig. 4.

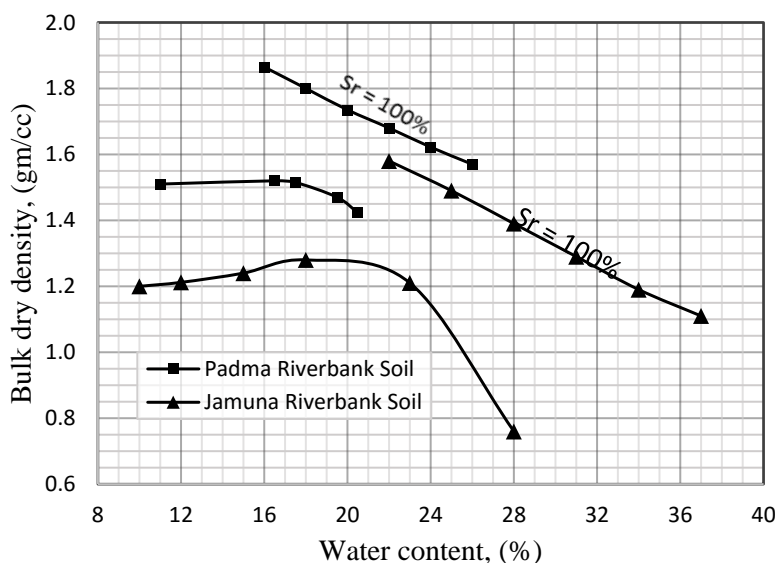
Fig. 2: Bulk dry density vs water content
