# **FIELD SURVEY OF THE HISTORICAL AND ARCHAEOLOGICAL BUILDINGS IN CHITTAGONG CITY, IDENTIFICATION OF FAULTS AND RECOMMENDATION OF PROBABLE RETROFITTING MEASURES**

F. Parvin<sup>1\*</sup>, M. A. Yusuf<sup>2</sup> & O. A. Chowdhury<sup>3</sup>

## RESULTS AND DISCUSSIONS

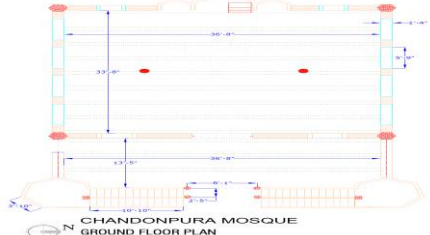
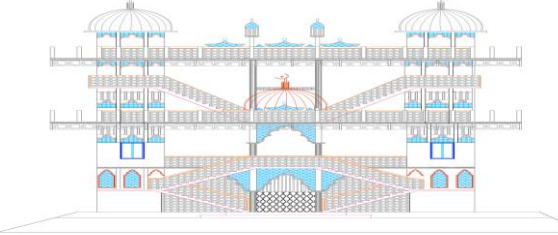
<p>Chandanpura Mosque                  ( Floor Plan &amp; Front Elevation )</p>

<p>CHANDANPURA MOSQUE                  GROUND FLOOR PLAN</p>

<p>FRONT ELEVATION</p>
<p>CRB                  (Chittagong Railway Building)                  (Ground floor plan and North side elevation)</p>

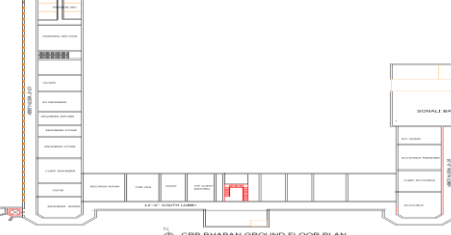
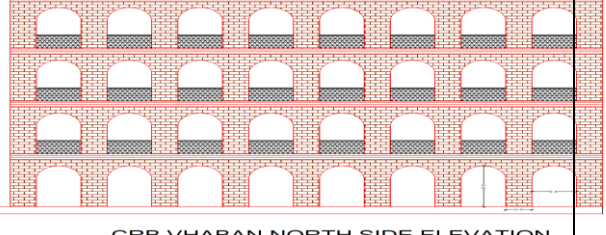
<p>CRB SHABAN GROUND FLOOR PLAN</p>

<p>CRB SHABAN NORTH SIDE ELEVATION</p>
<p>Zia Memorial Museum                  (Ground floor plan and Front elevation)</p>

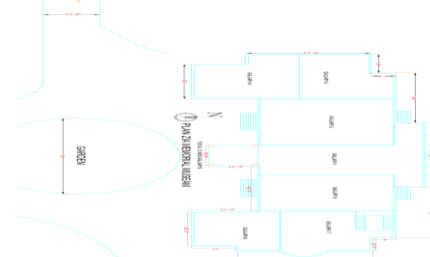
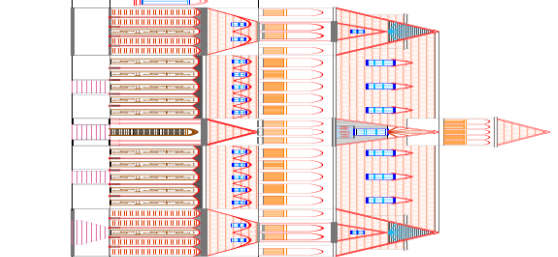
<p>ZIA MEMORIAL MUSEUM                  GROUND FLOOR PLAN</p>

<p>FRONT ELEVATION</p>
<p>Chittagong Railway Station                  (Old)                  (Ground floor plan and Front elevation)</p>

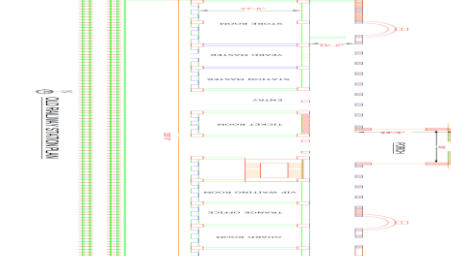
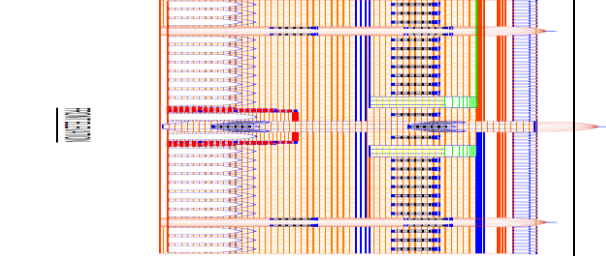
<p>CHITTAGONG RAILWAY STATION (OLD)                  GROUND FLOOR PLAN</p>

<p>FRONT ELEVATION</p>
<p>Chittagong Railway School Building and Chittagong Polytechnic Institute                  (Ground floor plan)</p>

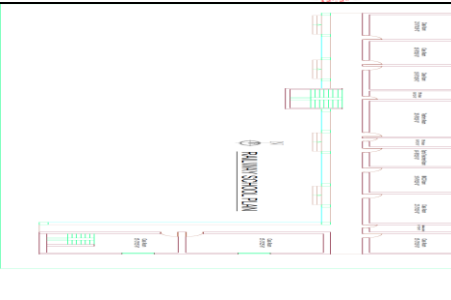
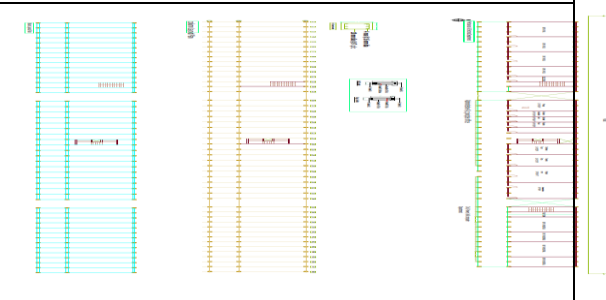
<p>CHITTAGONG RAILWAY SCHOOL BUILDING AND CHITTAGONG POLYTECHNIC INSTITUTE                  GROUND FLOOR PLAN</p>

<p>FRONT ELEVATION</p>

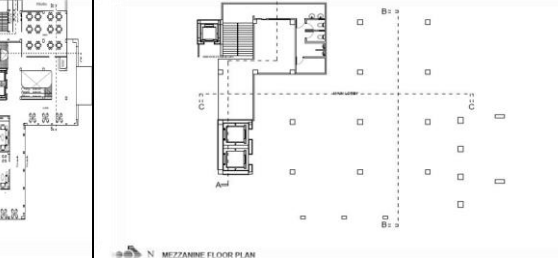
<p>Chittagong Club                  (Ground floor, 1st floor, Mezzanine floor plan)</p>

<p>CHITTAGONG CLUB                  GROUND FLOOR PLAN</p>

<p>1ST FLOOR PLAN                  MEZZANINE FLOOR PLAN</p>

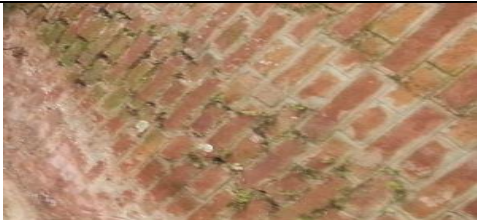
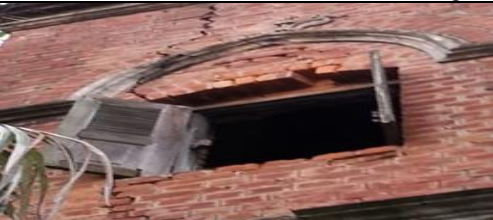
<b>Repair technique:</b> Plaster should remove properly in cracks area. Then apply de-salt chemical in the wall and re plaster . Ancillary part like railing crack fault should recast.		
<b>Crack in the wall</b>		
Cack in the wall (C.R.B)	Corrosion in the wall (C.R.B)	Cracks in the wall (old fire service building)

<p><b>Repair technique:</b> Cracks that are small in width (<math>\leq 0.75</math> mm) can be effectively repaired by pressure injection of epoxy (IS 13935: 1993).The surfaces are thoroughly cleaned of loose materials. Injection ports are placed along the length of the cracks on both sides, at intervals approximately equal to the thickness of the member. Low viscosity epoxy resin is injected into the ports sequentially, beginning at the port at the lowest level and moving upwards one by one. The resin is pushed through the packer till it is seen flowing from the other end or from a port higher than where it is injected. The port is closed at this juncture and the packer is moved to the next higher port.</p> <p>Larger cracks will require larger packer spacing depending on thickness of the member. Vacuum injection has a typical fill level of 95 percent and can fill cracks as small as 0.025 mm. A similar technique can be applied to strengthen weak walls.</p> <p><b>Re-pointing:</b> For re-pointing, first the wall should be made wet and all loose debris cleared. The joints that are to be re-pointed should be raked to a depth of 2 times the joint height. Next fresh mortar should be placed by trowels. The mortar should be non-shrinking type. The re-pointed portion should be cured properly.</p> <p><b>Grout Filling:</b> Selected cells in a hollow block masonry wall can be filled with grout. Filling the voids with grout will increase the compressive strength and make the wall more impermeable to water penetration. The inside of the cavity should be pre-wetted, then drained prior to grouting.</p> <p><b>Crack Stitching:</b> It is possible to introduce internal ties in a masonry wall by drilling a hole, placing a bar and finally grouting the hole. A similar ‘pinning technique’ can be used for stitching cracks in the walls and strengthening the arches.</p>

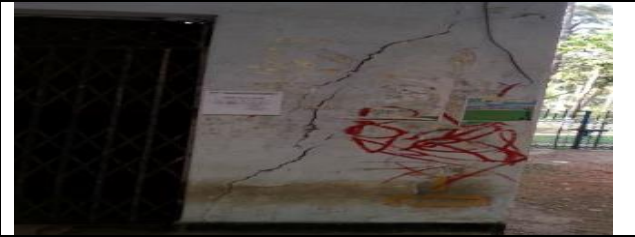
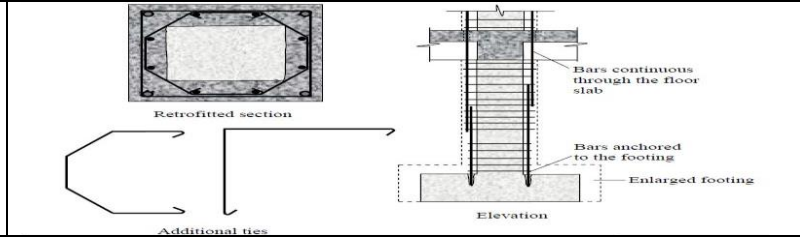
<b>Cracks in the column</b>		
Cracks in column (C.P.I)	<b>Repair technique:</b> Column jacketing method can be applied for re-strengthening the column

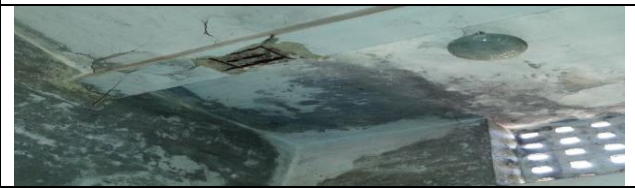
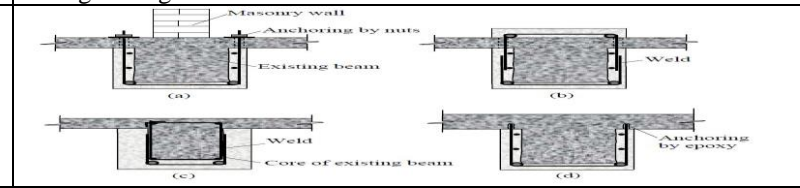
<p><b>Cracks in the Beam</b></p>	
<p>Crack &amp; corrosion of steel in beam (C.P.I)</p>	<p><b>Repair technique:</b> Beam jacketing method can be applied for re-strengthening the beam</p>

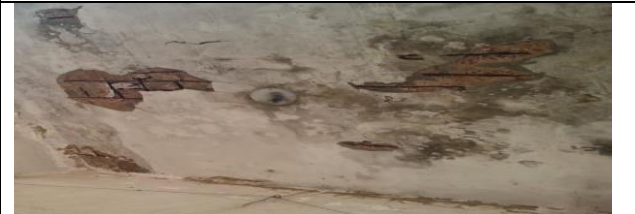
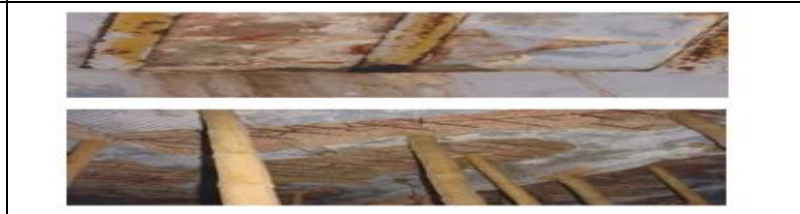
<p><b>Ceiling fault</b></p>	
<p>Corrosion of steel on roof (C.P.I)</p>	<p>Corrosion of steel on roof (Court building)</p>

<p><b>Repair technique:</b> Ceiling should re plaster after removing the old damaged plaster immediately to prevent steel corrosion and in R.B slab (reinforced brick) steel section can be repaired by applying anti corrosion chemical.</p>	
<p><b>Cracks on the floor</b></p>
