SEISMIC VULNERABILITY ASSESSMENT OF EXISTING BUILDINGS IN CHITTAGONG CITY: A CASE STUDY ON RAMPUR WARD

Keywords: Seismic vulnerability assessment; Turkish method; Rampur ward; Chittagong city

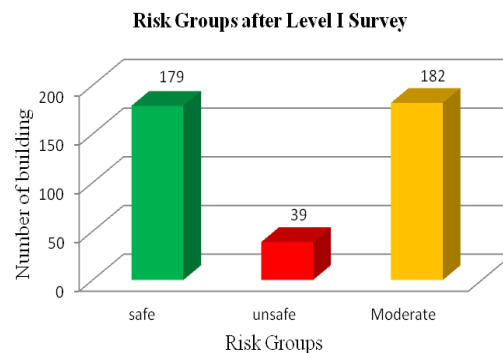
Fig. 10: Risk Groups after Level I Survey
