DETERMINATION OF WALKWAY USAGE INDEX IN MARKET AREA OF DHAKA CITY

ABSTRACT

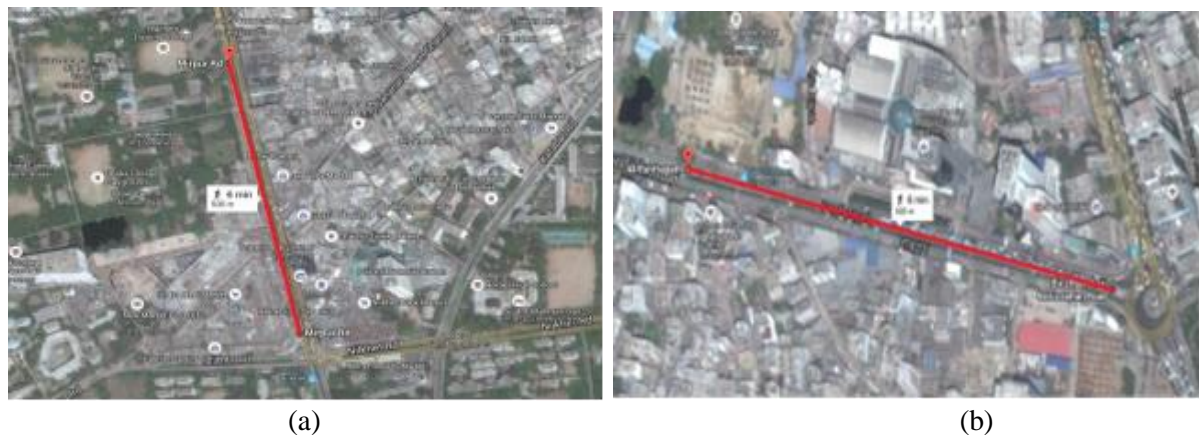
Fig. 1: (a) The selected 500m walkway in front of New Market; (b) The selected 500m walkway in front of Bashundhara City Shopping Mall.

In every location, a 500m long walkway was selected for the study. Then each walkway was divided into 5 segments. It means each segment was 100m long, total 10 segments of 1 km long walkway were considered to be surveyed.

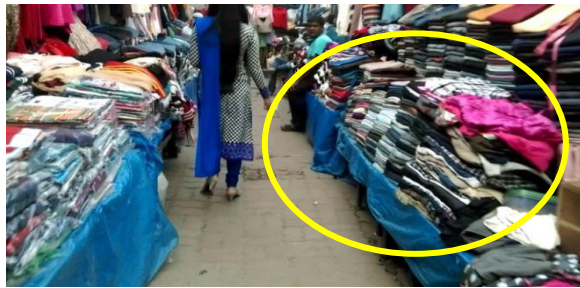
Walkway Occupied by Hawkers (New Market area)

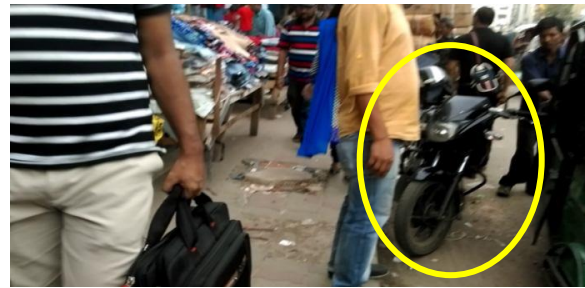
Obstruction on Walkway (New Market area)

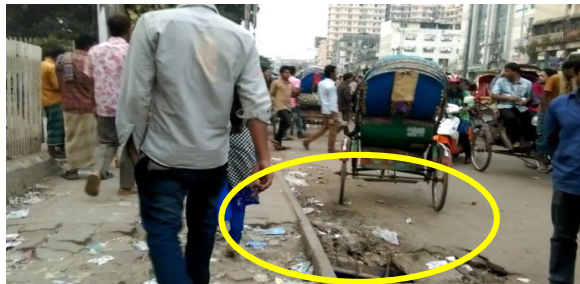
Poor Quality of Walkway (New Market area)

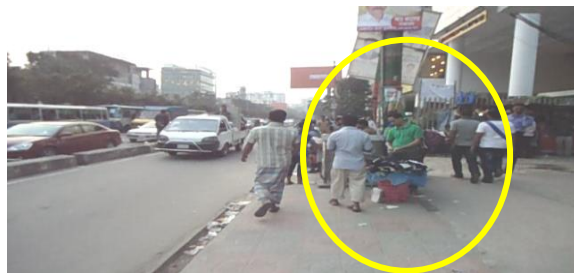
Presence of Hawkers (Bashundhara City area)

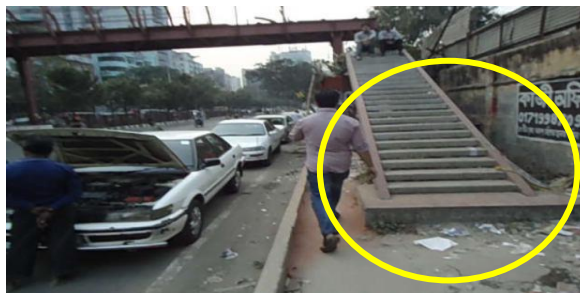
Portion of Over Bridge on Walkway and Construction Material on Walkway (near Bashundhara City market area)

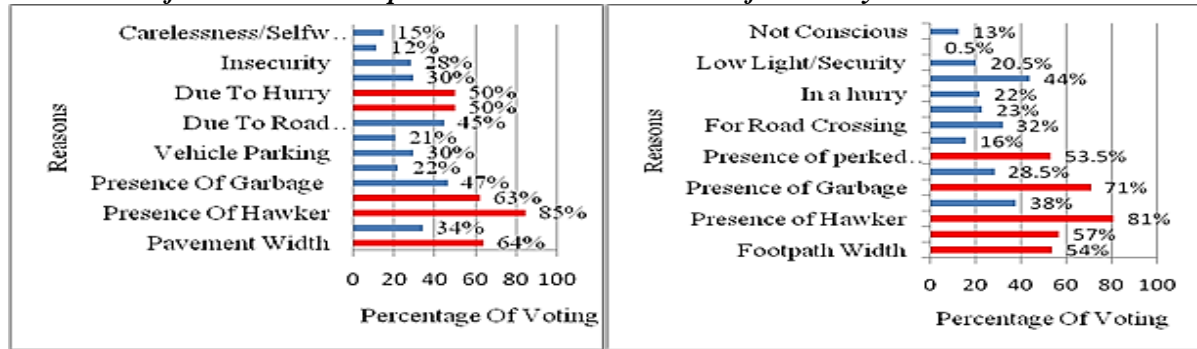
Fig. 4: (a) Graphical presentation of questionnaire survey (New Market: out of walkway); (b) Graphical presentation of questionnaire survey (Bashundhara City shopping mall: out of walkway)

The graphical presentation in Fig 4(a) shows in the New Market Area the presence of the hawkers on the walkway is the major reason that 85% pedestrian has chosen as their choice of the factors to walk on road. 64% pedestrians thought pavement width is the reason behind their walking on the walkway. In Bashundhara City area in Fig 4(b), 81% pedestrian has also chosen road to walk due to presence of the hawkers and 71% pedestrians avoid walkway to get rid of the presence of garbage. Therefore, it can be concluded that to dispel the hawkers on the walkway is one of the prior steps that should be taken in order to foster a huge number of pedestrians to walk on walkway.

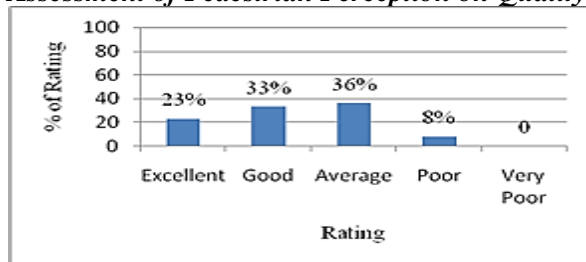
Fig. 5: Perception of Rating of New Market

In New Market Area analysis shows that 56% of the pedestrian’s observation was within excellent to good but 44% of the pedestrians rated the walkway to be average and poor. Thus it can be stated the walkway as an average service providing walkway which has rooms for improvement. In the Bashudhara City area, analysis shows that 64% pedestrians thinks the walkway to be good and excellent whereas 36% deemed the walkway to be average or below average in service quality.

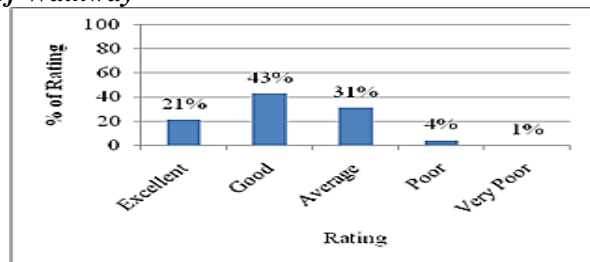
Fig. 6: Perception of Rating of Bashundhara City
