OVERFLOW OF MIRZA KHAL OF CHITTAGONG CITY AND IT'S EFFECTS ON ROAD

M. A. Hossain* & S. K. Palit

*Department of Civil Engineering, Chittagong University of Engineering and Technology,
Chittagong, Bangladesh*

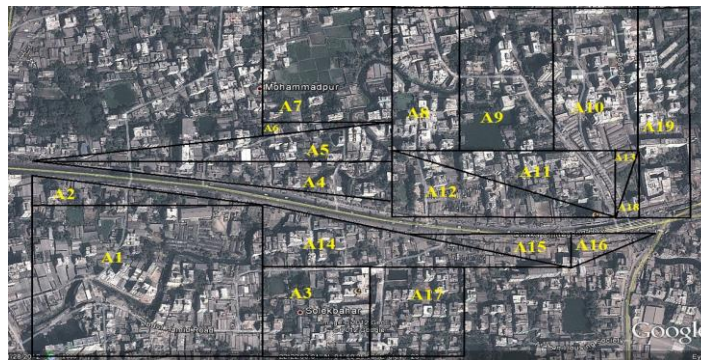
Fig. 3: Various Catchment Areas for determining the actual discharge in Mirza khal

For determining the actual discharge, total catchment area is divided into 19 small areas consisting of 1.13 km² which are illustrated in Fig. 3 and calculated total run-off is run-off 7.13m³/sec.

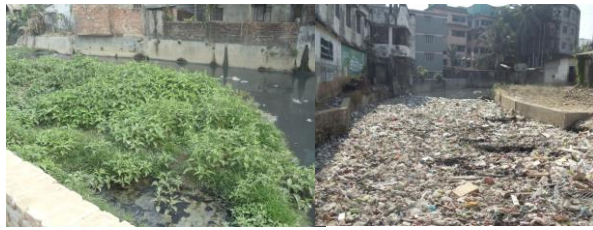
Fig. 5: Vegetation problem in Mirzakhai

Water logging tends to exclude oxygen from the soil and plants have evolved many ways to deal with this, leading to the evolution of hundreds of specialist wetland and waterside species which is known as vegetation. Vegetation problem arises after siltation takes place in the canal. Many places along the Mirzakhal are covered by the vegetation problem which is illustrated in Fig. 5.
