ASSESSMENT OF COASTAL SCOUR OF SANDWIP CHANNEL FOR DESIGN OF A JETTY

Keywords: Coastal scour; hydrographic chart; Sandwip channel; total scour; jetty pile

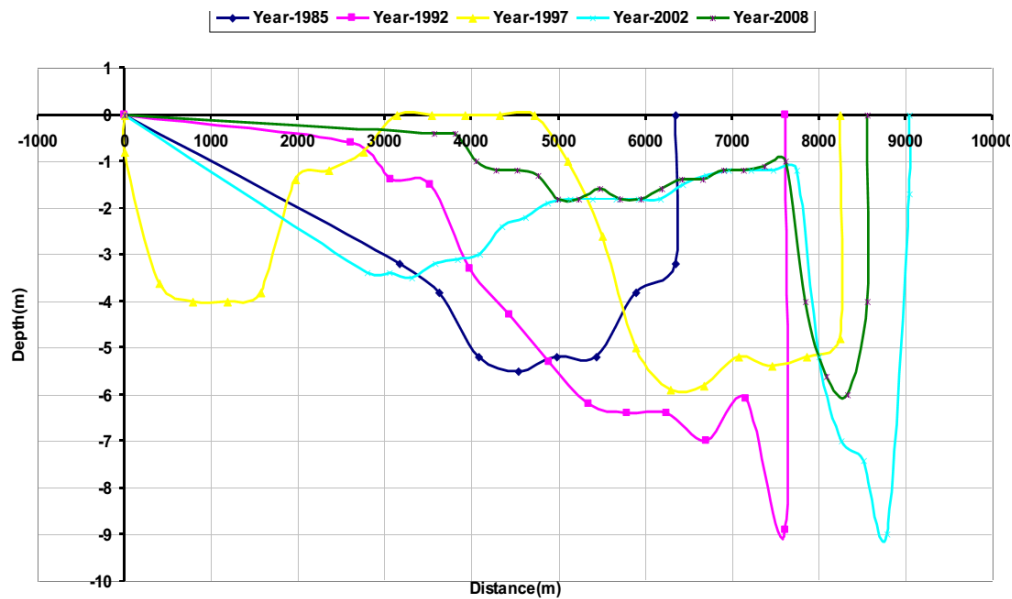
Fig. 2: Superimposed cross-sections of various years of Sandwip Channel
 (source: Reza, 2010)

*Morphology of Sandwip Channel:*Chittagong coastline remained relatively stable over the years. In the north, considerable accretion took place due to a closure damon the Feni river. The reason for its relative stability is perhaps the near-isolation of Sandwip Channel from the distributary network in recent times. Coastal plains are inundated every day by tides coming from sea. Sediments are generally consisting of clay with silty materials. It is worthwhile to mention that the present morphological features of the stream/creeks may alter due to any man-made activities as well as naturally induced hazards. At present, Sandwip Channel is tide-dominated, allowing a net import of fine sediments. Review of previous studies shows that the no significant changes in channel morphology have been observed. Reza (2010) analysed cross-sectional data of various years as shown in Figure 2. It is seen that maximum bed level changes to about 9 m at the thalweg.

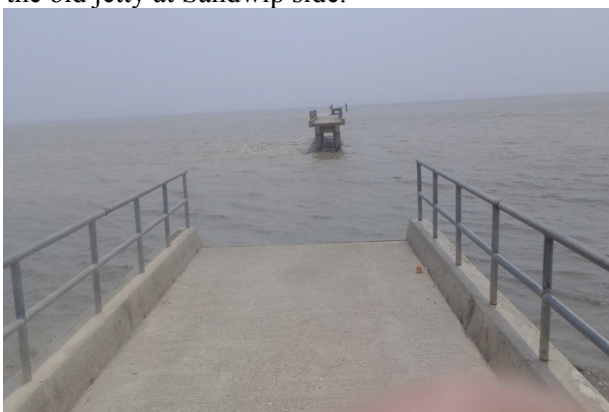
Photo: 1 Damaged BIWTA Jetty at Sandwip side at high tide
 (September, 2014)

Available formula for the computation of coastal scour has been analysed. As a thumb rule, local scour around a pile has been estimated as 2 to 3 times of pile diameter. However, some formula calculates the local scour due to current action and wave. Nearshore coastal piles are always vulnerable to both wave and current action. For a more complete description of scour prediction methods for scour at vertical piles can be found in Einstein and Weigel, (1970) and Herbich et al. (1984). Based on test results from a laboratory study, they made tests run to examine effects of waves, currents, and the combination of the two. Herbich et al. concluded that scour at the base of vertical piles caused by wave action alone is insignificant when the piles are in relatively deeper locations. They proposed a procedure consists of number of empirical (laboratory based) equations to estimate both local and total scours. The procedure has been adopted for present scour calculation. Hydraulic data used in this analysis were collected from secondary sources (Hydrographical data collected from BIWTA). Field visit has also been made in September 2014 to observe the tidal and morphological characteristics at Sandip channel at the vicinity of proposed site where BIWTA jetty would be constructed. BIWTA constructed a landing Jetty at Swandip channel in early year 2000 to facilitate inland passengers and cargoes and they cross the channel to Sandip headquarters from Kumira (Shitakunda). Unfortunately this jetty has not been operational in last 15 years due to considerable damage immediately after its construction. Reasons of such damage of jetty have not been explored, but it can be anticipated that proper design and constructional procedure might not been maintained. Some recent photographs (Photo:1 to Photo: 4) are shown to observe the condition of the old jetty at Sandwip side.

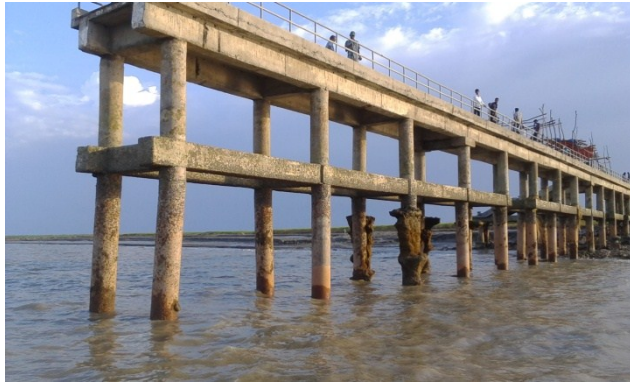
Photo:3 Damaged BIWTA jetty at Sandwip side low tide
(September, 2014)

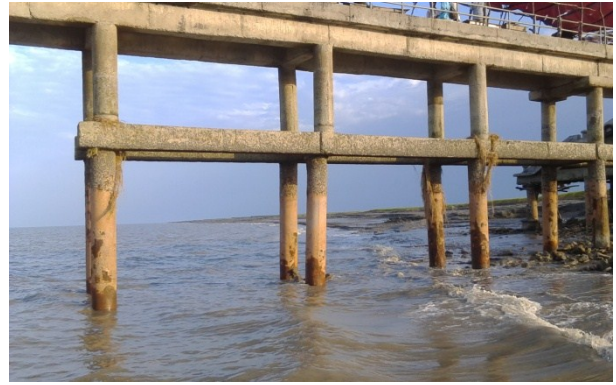
Photo:4 Damaged BIWTA jetty near shoreline at
Sandwip (September, 2014)

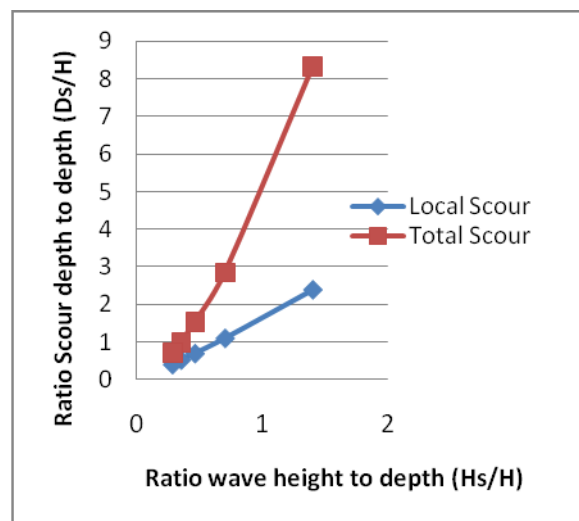
Fig. 6: Scour Depths ratios (D_s/H) Vs. (H_s/H) for $H_s=7m$, $T=3s$

Local scour and total scour for various wave length and wave period have been computed. As for typical results, Fig.3 to Fig.6 show the variation dimensionless scour depth (D_s/H) for various dimensionless wave heights (H_s/H) for various combinations of wave heights and periods. It is seen that total scour depth (D_s) is much higher compared to local scour for a given pile diameter and bottom velocity. The computed scour depths are very much sensitive to wave height (H_s) especially at shallower water depth (H).
