## FAILURE ANALYSIS AND RECTIFICATION OF FISH MOUTH LIKE RUPTURE IN SUPERHEATER TUBE

**Abstract-** The present study is related to the superheater tube failure of Boiler-1 which is under operation at Karnaphuli Fertilizer Company Limited (KAFCO). Superheater is a crucial component of any boiler, and its failure leads to the shutdown of the entire plant. We investigated a fish mouth shaped rupture on the SA213-T11 secondary superheater coil that failed after running 78,840 hours. The reason for the fish mouth like rupture is short term overheating may be due to a restriction of steam flow for blockage inside tube although later no tube blockage observed by boroscopy inspection. Boroscopy was carried out in both headers if the tube is totally/partially plugged to prevent a second failure, and a videoscopic inspection was performed to find scale formation inside the tube. In the rectification process, the mellographic test was done to understand failed tube condition and identify the appropriate repair solution for short-term operation. Although the hardness tests of failed tube near the positions of welding ensured the suitability of replacement at reduced operating pressure, the ex

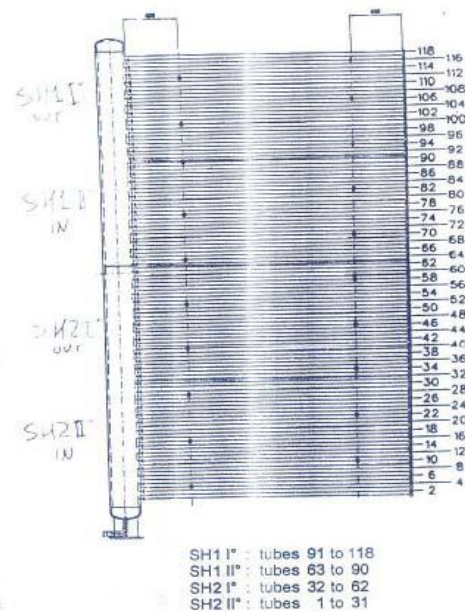
Fig.2: Schematics of the superheater tube assembly

After shutting down the boiler, it took around 14 hours to cool down the boiler for internal inspection. Preliminary visual inspection revealed that, first tube of Secondary Superheater inlet (SH2 I<sup>0</sup>) (Tube No. 62) was ruptured and fish mouth appearance at ruptured spot was observed. Due to sudden rupture of tube no. 62, the outer leg of the tube heats the inner leg. Due to high pressure and temperature steam hydrojetting, adjacent tube No 61, 63, 64, 65 was found magenitite formation at tube outer surface and blackish scale was formed at the steam contact points. Fish mouth opening was estimated roughly 100 mm and at the edges of the mouth cracks are observed. The rupture tube was found bulged and bended due to the reaction force of leakage. The leaked tube bowed at inner direction around 16 inches.

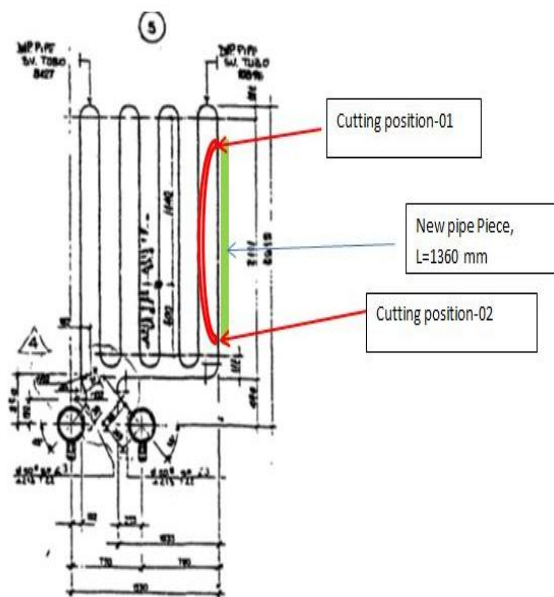
Fig.5: Secondary super heater coil.

As per MACCHI's short time repair procedure, it was decided to replace the ruptured portion with the section of spare tube available with us. As shown in the above figure, it has been observed that significant change of diameter and thickness value occurred in the right side of the rupture, minor change of hardness value observed along the tube length. Sound tube portion can be utilized for welding by removing at least 300 mm from both edge of the cracked portion. However, we cut off the length of 1380 mm and connected a sort piece from a spare tube coil.

1. Cut off damaged portion by length as long as the condition was found good. It was 1380 mm.
2. Straighten the tube end by heating (using gas burner) at bend position
3. Both end preparation

1. Cut a short piece of desired length from spare coil (Material SA 335 –T22).
2. Window cutting for inside welding form new short piece.
3. Outside and inside beveling to match with existing tube end.
4. Insert new short piece with maintaining root gap 2 to 3.2mm.
5. Root pass welding with GTAW process using Filler TGS-1CM (AWS 5.28 ER90S-G), Ø 2.4 mm.
6. DPT (dye penetrant test).
7. Final welding using GWAT process.
8. Installing the window by tack welding, that was cut to facilitate.
9. Root pass welding all around the window using Filler TGS-1CM, Ø 2.4 mm.
10. DPT.
11. Final pass welding all around the window using same filler.
12. RT(Radiographic test)
